Unintended radiation dose due to MLC planning error identified by Cherenkov Imaging.¹

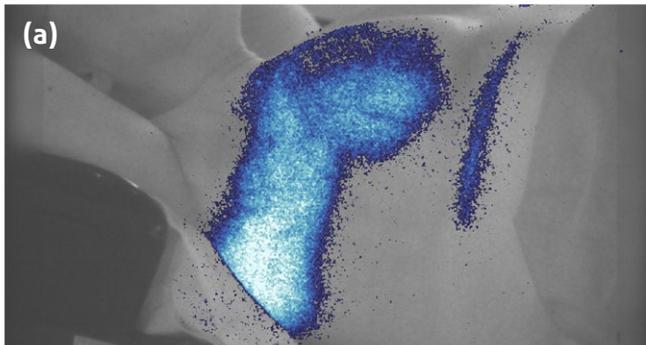
(a) A Cherenkov image taken during treatment revealing a sliver of dose to the lower chest.

SUMMARY: The Cherenkov image taken during treatment (panel a) shows an open MLC on the lower chest wall. This was observed by the clinical team as a potential anomalous event. Subsequent review of the treatment plan revealed that the Cherenkov image matched the expected surface dose (panel b) and that the open MLC was inadvertently left open during planning.

DISCUSSION: The strip of dose on the inferior of the breast from the open MLC was only identified after reviewing the Cherenkov images taken during treatment. This sliver of dose did not seem consistent with the prescribed treatment and prompted an investigation. A review of the patient plan (panel c) revealed that the open MLC in question occurred on only one brief segment of the treatment and did not pose a significant exposure risk to the patient. The clinical team also investigated why it was not identified during the routine plan check and determined that it was a result of how the MLCs and jaws are represented in the TPS software. For this particular plan, the offending open MLC was directly adjacent to the jaw edge as indicated by the arrow in panel c, and the software representation of the open MLC and the jaw make it difficult to determine where one ended and the other began. As a result, the single open MLC was missed in the review of the plan this is not something that would have been caught during patient setup with the field light nor during routine imaging.

KEY LEARNINGS: Cherenkov imaging was able to capture a planning error of a single MLC. Fortunately, this event did not result in harm to the patient, however, it did identify a potential systematic failure mode in the planning process, which, under different circumstances, could lead to patient harm. An important outcome from this event is to ensure TPS viewing settings are set such that open MLC and jaw edges are clearly distinguishable.

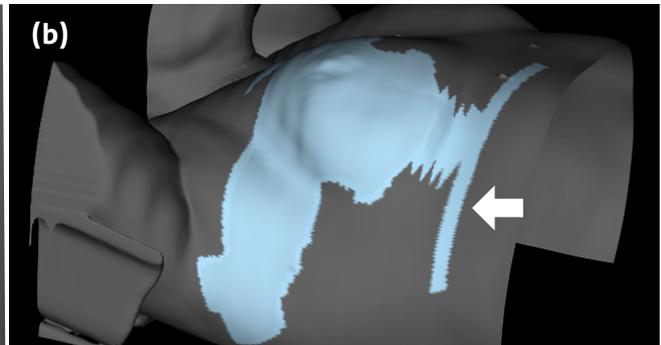
(b) The planned surface dose prediction from TPS, overlaid on the patient CT.

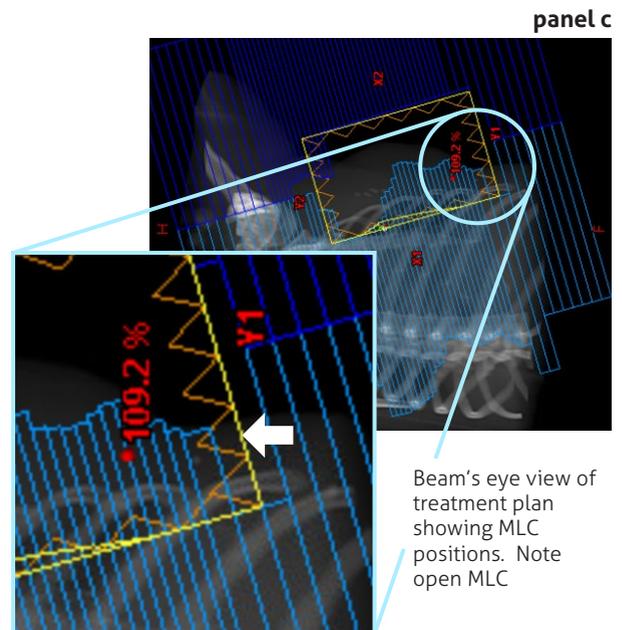
panel c
Beam's eye view of treatment plan showing MLC positions. Note open MLC
